FINAL REPORT ON

ENGINEERING TEST

RECOVERY VEHICLE, FULL-TRACKED,

XM806E1

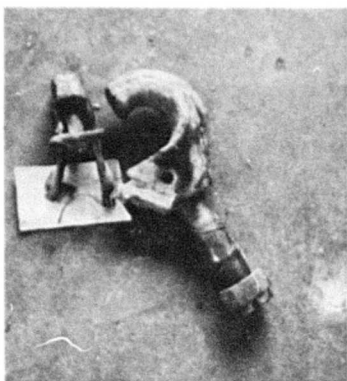
The standard M113A1 towing pintle was not sufficiently durable to withstand the loadings imposed during towing operations. A larger tow pintle (M548 type) was installed and found satisfactory for 1024 miles of towing operation.

Figure II-20: Typical Failure of Standard M113A1 Tow Pintle.

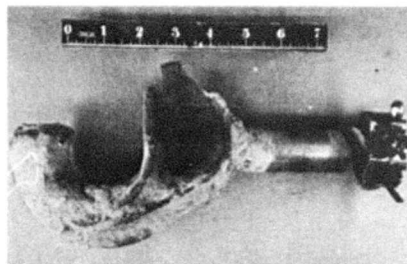
Figure II-21: Towing Pintle That Failed After Towing An M113A1 For 59 Miles Across Level Cross-Country Terrain.

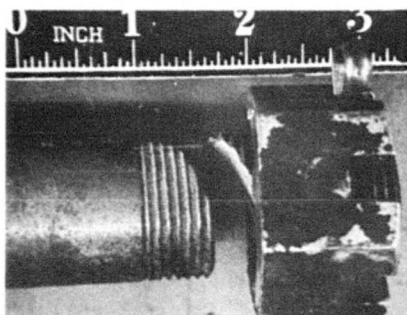
Figure II-22: Side View and Close-Up of Failed Area. Shaft Appears to Indicate a Shear Failure, However, Failed Surface Indicated a Tensile Failure. Angled Break Probable Occurred When the Vehicle Negotiated A Bump on the Cross-Country Course.

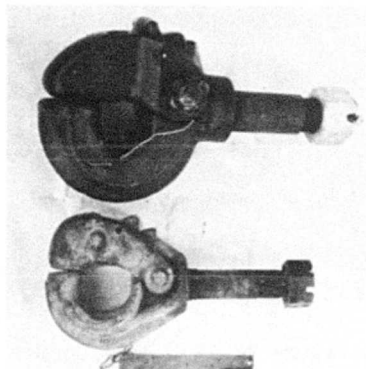
Figure II-23: Standard M113A1 Tow Pintle Is Shown Below Larger Pintle (M548 Type) That Was Satisfactory for 1024 Miles of Towing Operations. Six Inch Ruler Indicates Relative Size Difference.

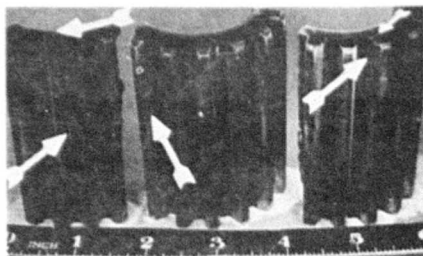
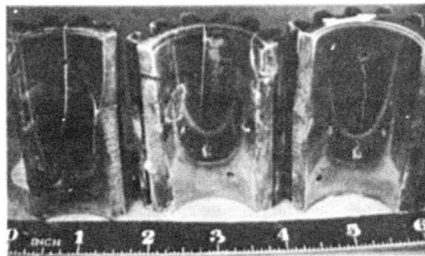
Winch gear-train failure from poor quality control of material properties was the only deficiency reported during the test. The gear failure occurred after 59.8 winch hours.

Figure II-24: Internal and External Views of Winch Stage Three Carrier Housing Planetary Gear That Failed After 59.8 Winch Hours. Arrows Indicate Cracks That May Either Have Resulted from the Impact Loading At the Time of Failure or from Material Weakness.

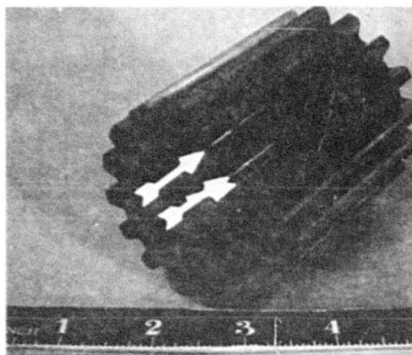
Figure II-25: Spur Gear from the Same Housing as the Failed Gear Shown in Figure II-24. Arrows Point to Cracks Along Tooth Roots.

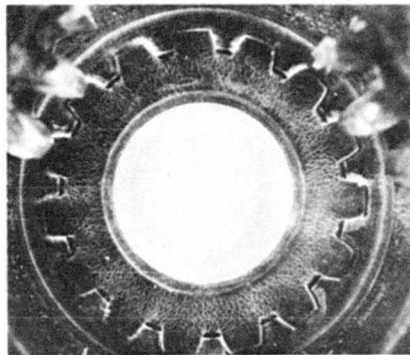
Figure II-26: New Second Stage Sun Gear As Received from the Manufacturer. The Assembly Was Intended for Use As A Replacement Component. Surface Cracks Probably Resulted from Heat Checking during Grinding Operations.

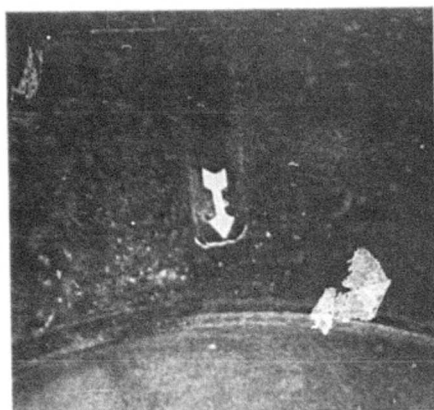
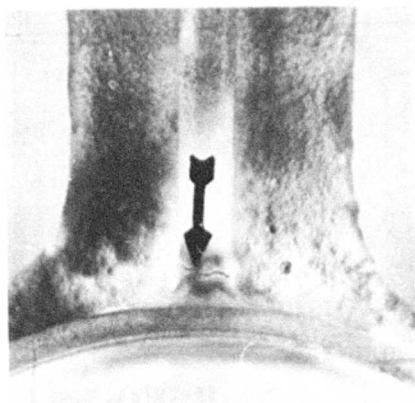
Figures II-27(a) and II-27(b): Arrows Point to Typical Cracks Found in Level Wind Floating Pulley Spoke Support Ribs. Figure II-27(a) Shows Pulley for the XM806E1 Vehicles and Figure II-27(b) Shows the Pulley for the M113 Recovery Vehicle.

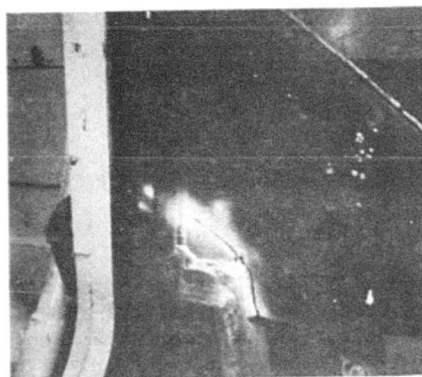
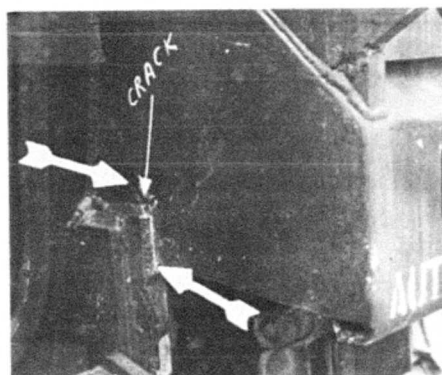
Figures II-28(a) and II-28(b): Figure II-28(a) Shows Crack Found in Right Fender of the XM806E1 during Final Inspection. The Crack Has Been Accented with Dye. Figure II-28(b) Shows Right Fender After the Final Inspection of M113 Recovery Vehicle.

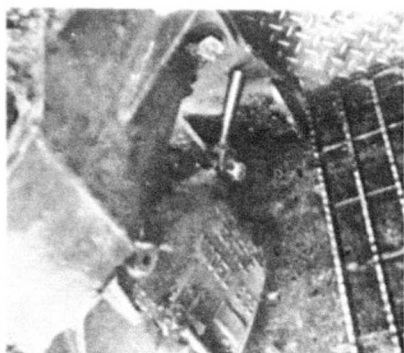
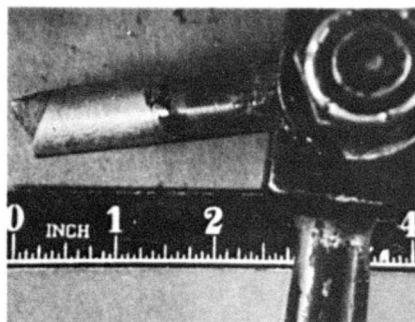
Figures II-29(a) and II-29(b). Figure II-29(a) Indicates How Fairleader Had Rotated Where Fairleader Mount Has Interfered with Tensioner Handle. Torsion Failure of Tensioner Eyebolt Is Shown In Figure II-29(b) When Handle Struck Mount.

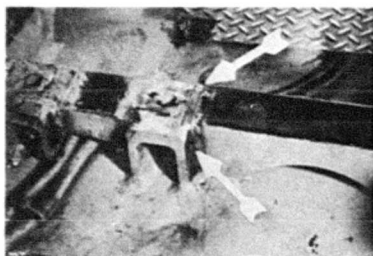
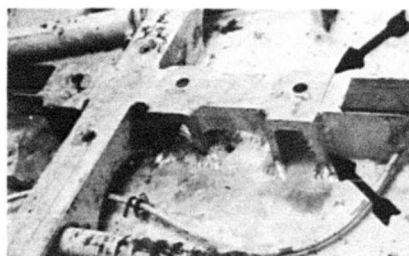
Figures II-30(a) and II-30(b). In Figure II-30(a) Arrows Indicate the Length of the Left Front Hull Channel Mount Crack Found After the XM806E1 Test. Figure II-30(b) Shows Similiarity in Defect Found After M113 Recovery Vehicle Test.

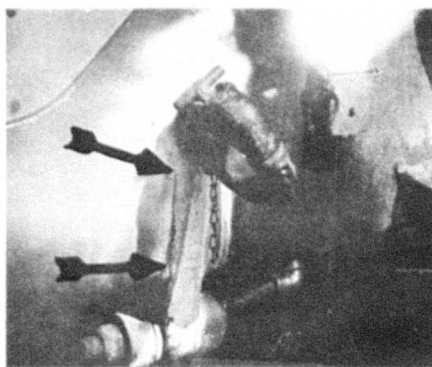
Figure II-31: Arrows Indicate Length of Crack Propagating Along Left Weld of Ramp Center Hinge Support Rib After 972 Miles of Towing. A Dye Penetrant Was Used to Accent Crack for Photographic Affect. The Actual Crack Is A Hairline and Not of the Width Indicated by the Dye.

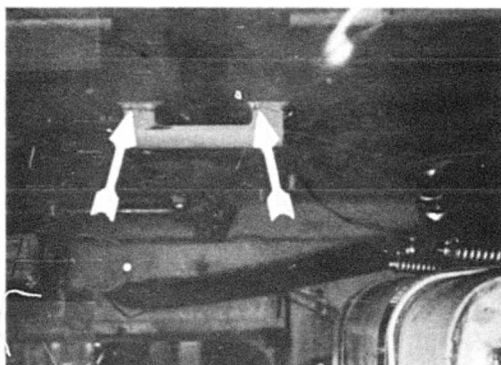
Figure II-32: Arrows Indicate Cracks Found in the Welds Securing the Control Valve Bracket to the Hull Deck after 88.8 Winch Hours. The Bracket Is Identical In Design Along the Forward Edge. Cracks Were not Found in the Forward Welds.
